AFWAL-TR-84-2014

IMPROVEMENT OF THE CORROSION RESISTANCE OF TURBINE ENGINE BEARINGS

United Technologies Corporation
Pratt & Whitney Aircraft
Engineering Division
P.O. Box 2691, West Palm Beach, Florida 33402

Interim Report for Period August 1981 — July 1983

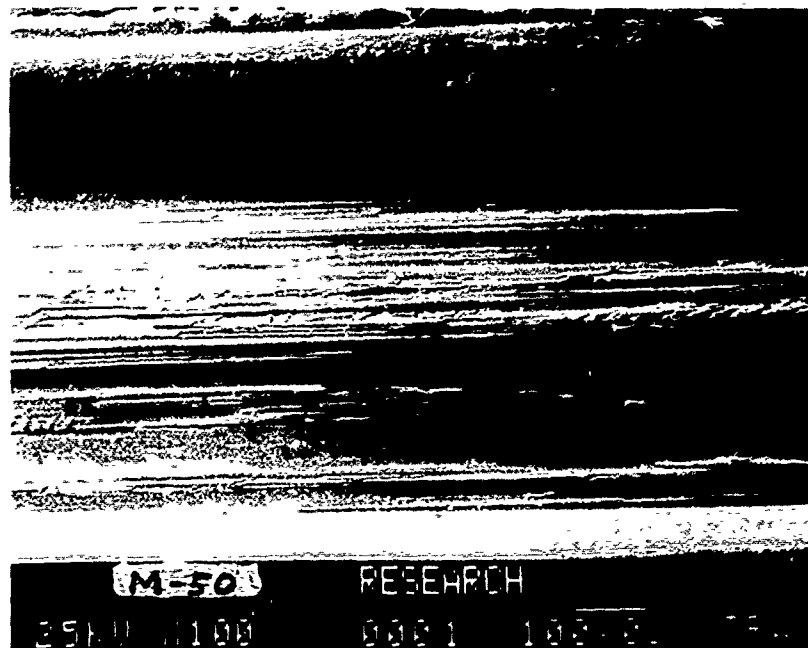
Figure 92. SEM Photograph of the Bottom of a Typical Wear Scar on an M50 Stationary Bar. Magnification: 100×
